OrderPlans

Lidar Scan-to-Plan Solutions

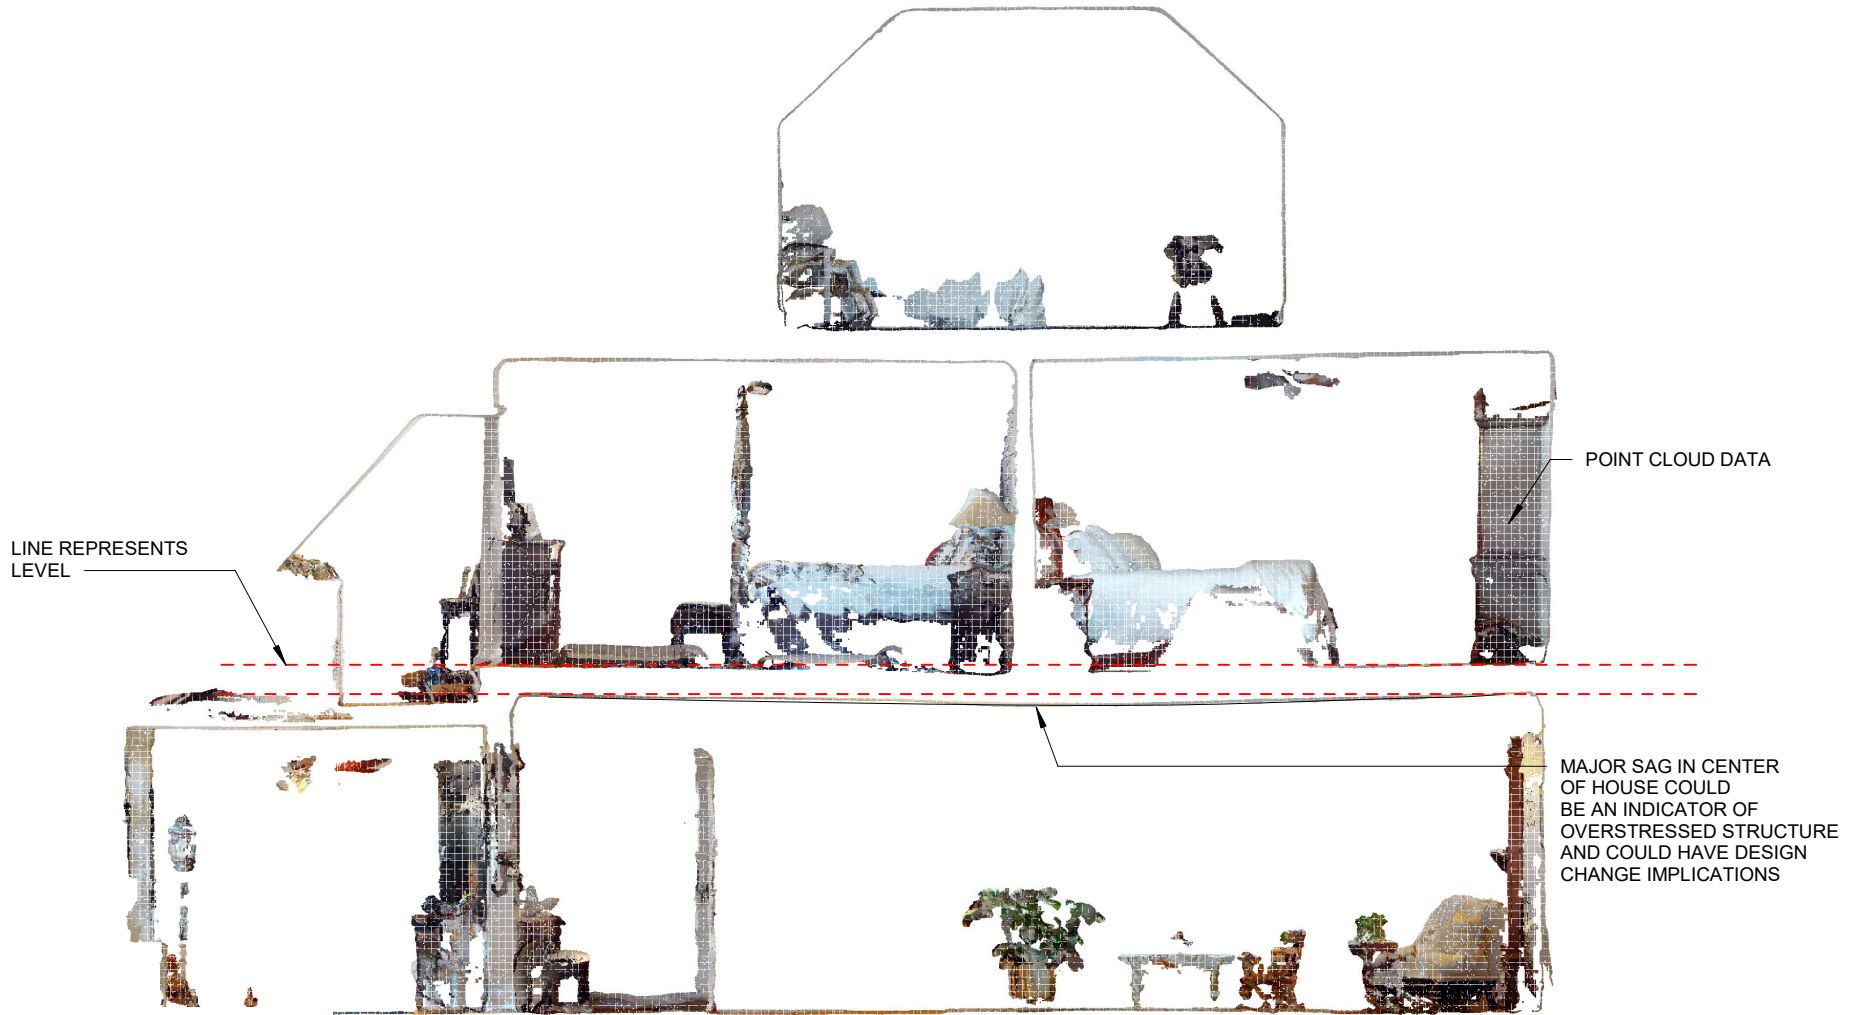
A STEP UP INTO THE ADDITION
WAS BUILT INTO THE DESIGN
AS A SOLUTION

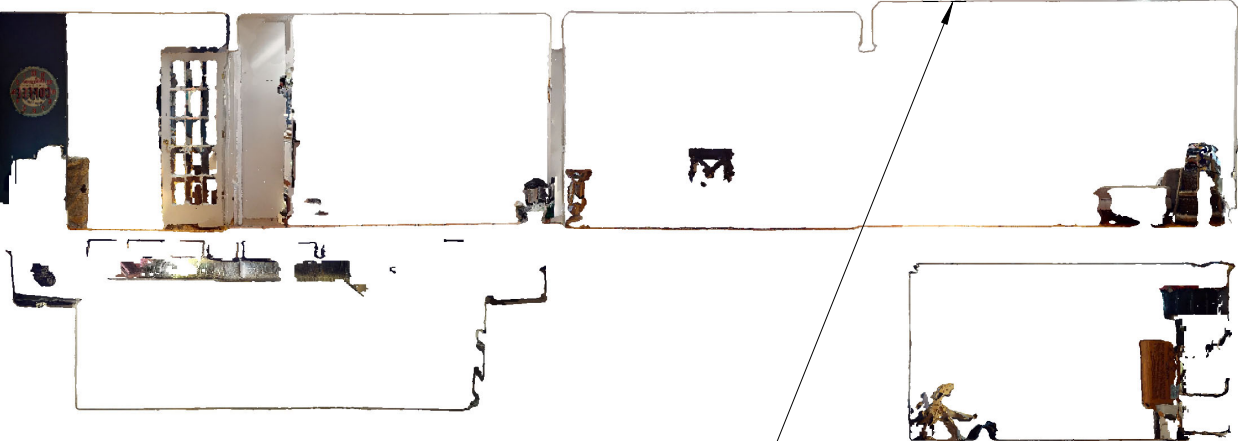
AREA OF PROPOSED
MASTER SUITE

HIGHER CEILING IN THIS AREA DID NOT ALLOW FOR
THE REQUIRED STRUCTURE

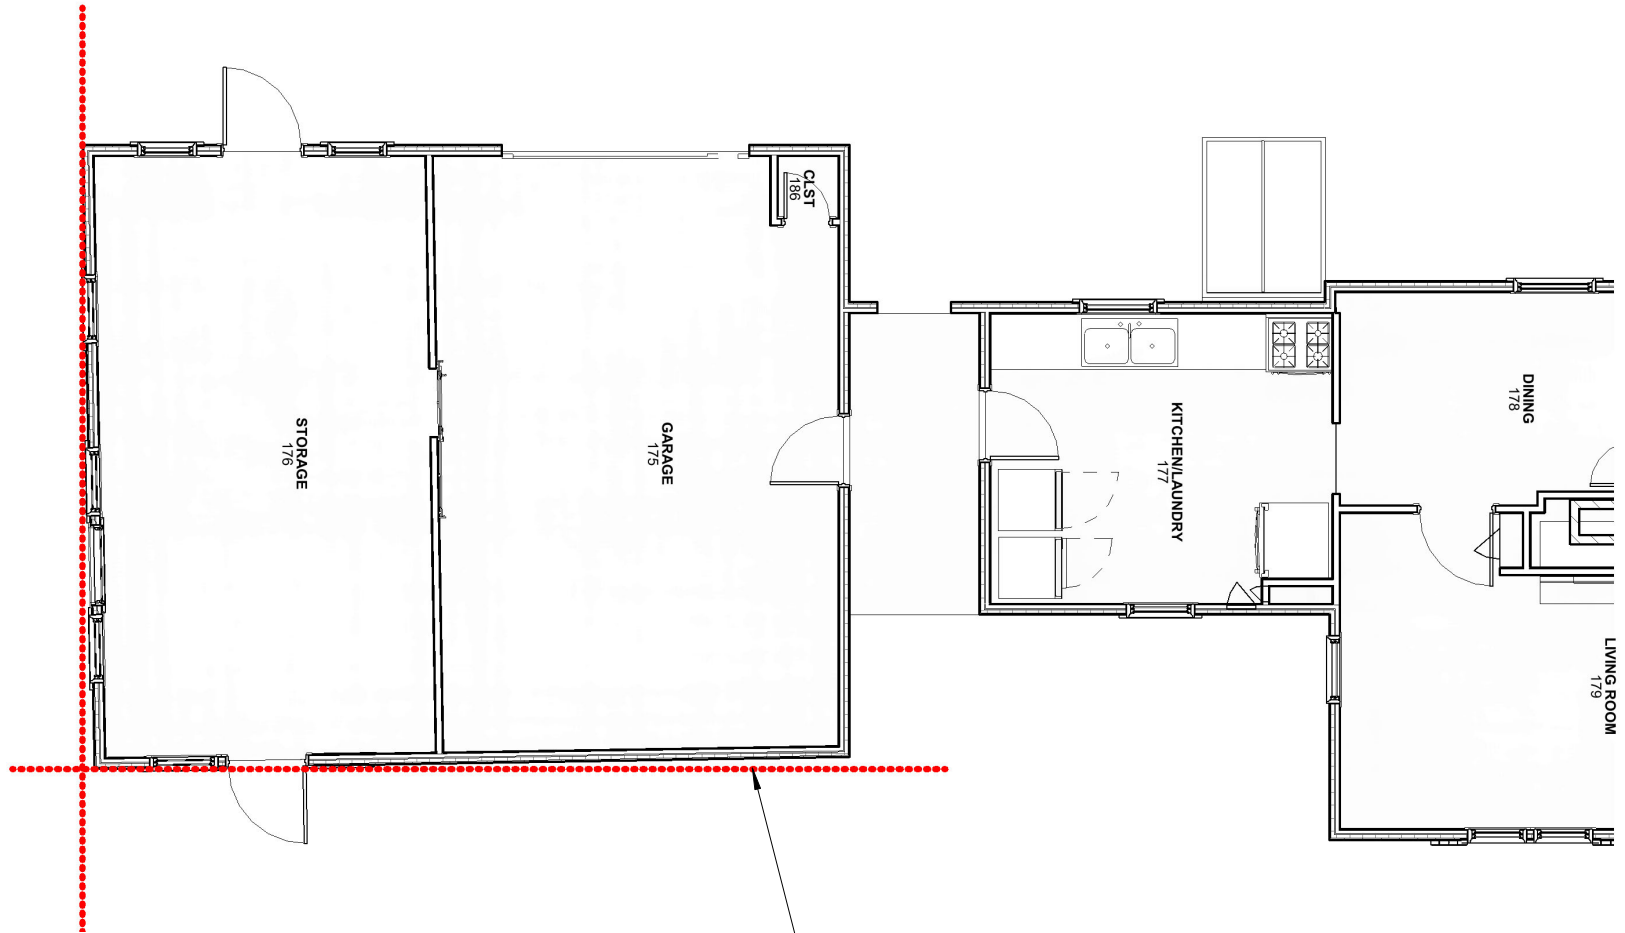
GARAGE AND STORAGE AREA
2 DEGREES OUT OF SQUARE
FROM THE MAIN BUILDING

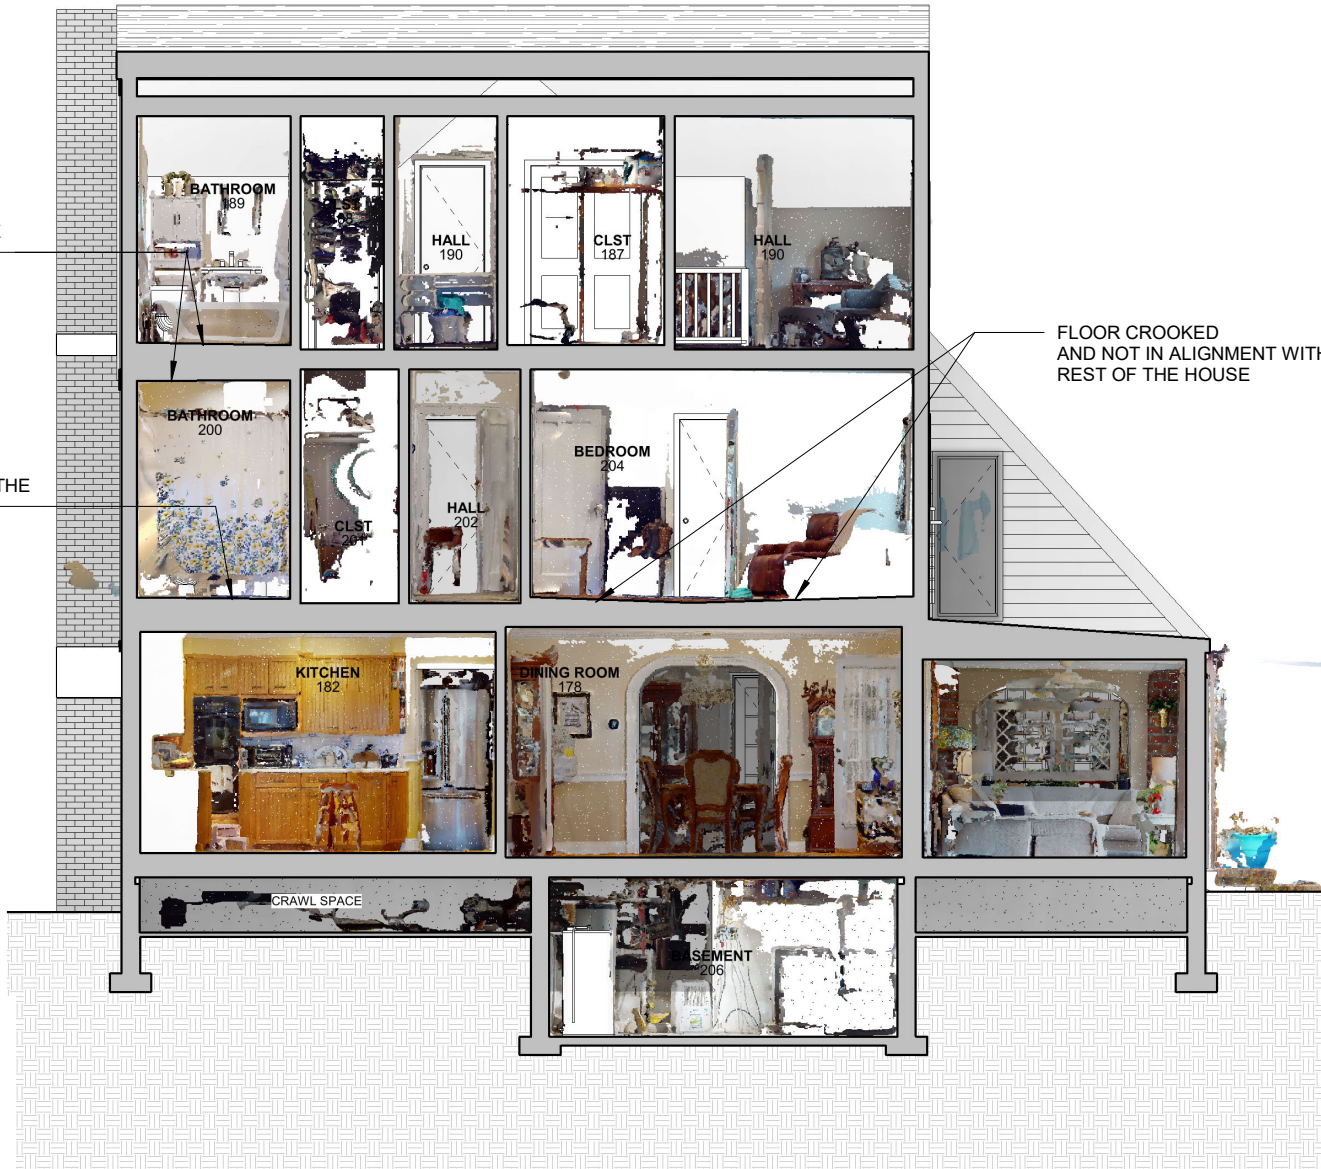
FLOOR AND CEILING CROOKED
AND NOT IN ALIGNMENT WITH THE
REST OF THE HOUSE

FLOOR CROOKED
AND NOT IN ALIGNMENT WITH THE
REST OF THE HOUSE
